Investigation of Equipment Elements of the Niğde Ömer Halisdemir University Campus in Terms of Aesthetics and Functional Properties[#]

¹Landscape Architecture Department, Faculty of Architecture, Niğde Ömer Halisdemir University, 51240 Niğde, Turkey

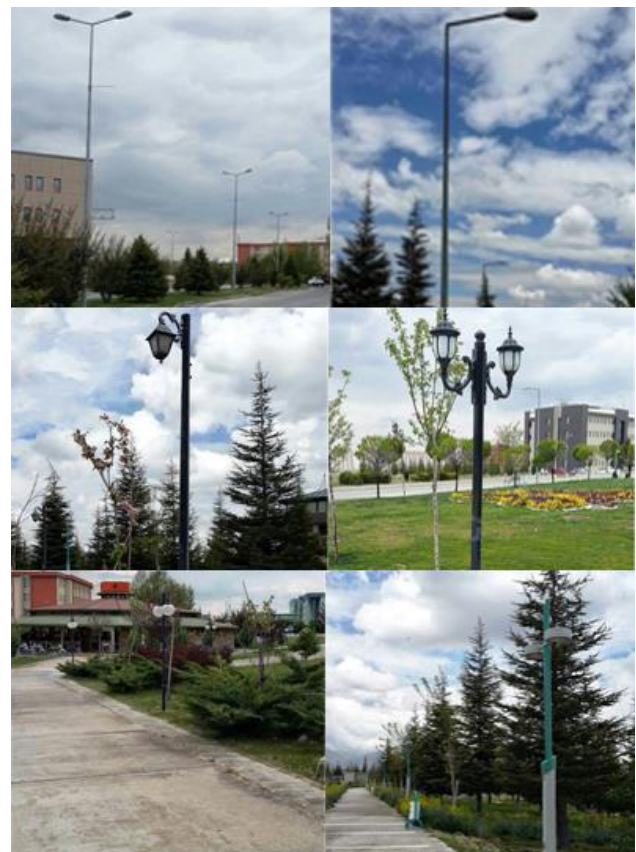
Figure 3. Lighting examples in campus

Campus have the lighting elements which has different features according to land use. Lighting elements of 11-12 meters in length on main roads, and 8 meters in length on intermediate roads are used.

While lighting elements with a length of 3 meters are preferred on pedestrian roads, lighting elements with a length of 1 or 3 meters are preferred in landscape areas. While concrete poles are generally preferred in lighting elements, it is possible to see examples of metal poles. It is possible to see LED and eco lamp types as well as sodium or mercury vapor lamps in the campus. There are problems in terms of lighting in some areas due to reasons such as negligence and deterioration in the campus. Lighting elements cannot reflect the identity of the campus in terms of aesthetics. The sequential rhythm, which is formed by repeating the in regular rows, dominates the lighting elements, and there is repetition, balance and emphasis by the design principles. Although the material and color which are used in the lighting elements, are integrated with the texture of the campus, the designs are not unique when evaluated for suitability and authenticity. Lighting elements that are used in the vehicle roads, comply with the standards in terms of size and ratio, but its lack of human scale affects its functionality and aesthetics negatively.

There is no lighting design in Akkaya Dam, which is of great importance within the campus. Lack of lighting design in such an area was found to be quite incomplete in terms of visual quality of the campus. However, we can say that lighting on pedestrian and vehicle roads is partially sufficient. Lighting examples in the campus are given in Figure 3.

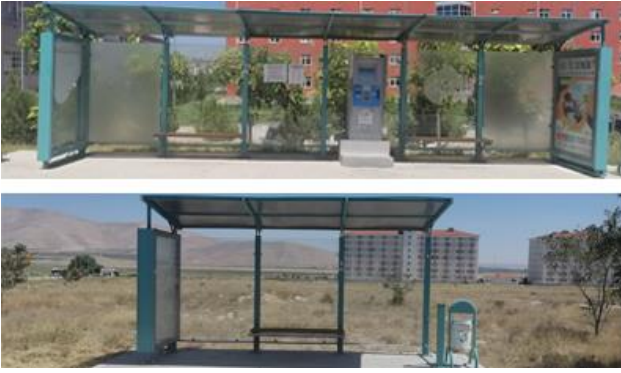
Figure 4. Bus stops examples in campus

There are a total of 6 bus stops on the campus. This number was found insufficient due to the absence of a bus stop near the some administrative and academic buildings in the campus. The bus stop on the campus is considered sufficient in terms of aesthetics and environmental compatibility. In the design of bus stops, inox and glass were used as materials. There is a wooden sitting element inside the bus stops.

There is no compliance problem among the materials. Side frames of the bus stops are used for advertising or information purposes. This features adds functionality to bus stops. Bus stops in the campus are given in Figure 4.

Depending on the land use in the campus, the location and size of the bus stops should be reconsidered and designed accordingly. In the Niğde, especially the winter months are quite cold. Building the stops in a way that can be closed in the winter will increase the functionality of these areas. The number of telephone booths in the campus is insufficient. However, it is sufficient according to the number of users. The biggest problem in these areas is that

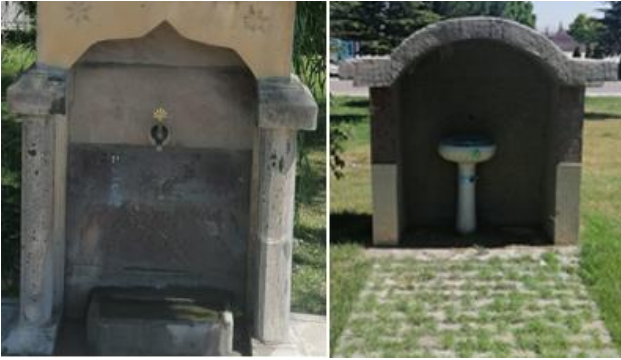
Figure 5. Fountains in campus

In the study area, there are 3 fountains with similar designs. One of them is at the entrance of the campus, the other is near the dining hall and the last one is in the area where the student residence are located. The locations of the fountains in the campus do not affect the pedestrian roads. The color of the material that was used for the fountains, is in harmony with the area and urban texture. Their designs are not unique. No incompatibility was observed in the measure-ratio balance with the areas and the human scale.

Functionality is at the forefront of the fountains and they do not have an aesthetically high quality appearance. The fountains in the campus are made of natural cut stones as materials. The fountains are on a human scale and it is determined that they are compatible with the historical texture of the campus. However, it was determined that the fountains were insufficient for the originality. Fountains are sufficient in terms of location, perceptibility, maintenance, unity and integrity. Fountains in the campus are given in Figure 5.

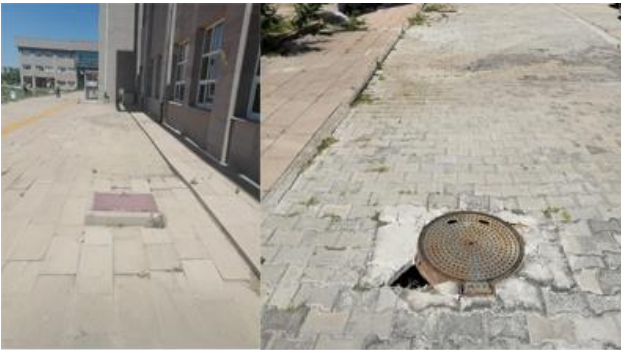
Figure 6. Infrastructure facilities covers

These are the covers placed on the ground in order to reach the arrangements and maintenance of the infrastructure installations such as gas, city water, telephone, electricity, sewage and rain water in urban areas. There are manhole covers, communication covers and gas covers in the campus. Iron was preferred as material. They are generally located on pedestrian or vehicle roads. This causes problems in terms of functionality. The fact that it was covered with iron material made these equipment lacking in terms of aesthetic appearance. In addition, it was determined that collapses occurred in these equipment due to negligence, and they caused problems in terms of functionality in the campus. Infrastructure facilities covers in the campus are given in Figure 6.

the measures are not suitable for individuals with disabilities. These areas should be designed in accordance with the disabled people. Manhole, natural gas, and electric cover on the campus, cause problems in terms of functionality and aesthetics. These areas should be designed in a way that does not prevent pedestrian transportation. In addition, these areas cause sudden elevation changes on the pedestrian roads. The elevation changes at these points should be corrected by excavation and filling works. The current design of the fountains is unique and compatible with the campus. Only maintenance and repair of fountains will increase the use of them. Floor coverings should be maintained regularly, should not pose a threat to city users and should not disrupt the urban aesthetics. The ramp and routers that meet the accessibility criteria especially for the disabled, should be maintained. Seating elements should be designed to be specific to the area and a good lighting design should be made for these areas. Trash cans that are used in the campus, should also be handled within the integrity of a design, color, texture and material. All of the restriction elements in the campus should be removed. Natural limiters should be preferred instead of these elements. Urban equipment elements should be attentive and original in their designs, and the environmental, color and material harmonies among themselves and the city. They should be analyzed well, and should be regularly maintained for a quality and clean city. The values of the city should be analyzed well and urban equipment elements should be added to these values. Unless urban equipment is unique to the city, there will be a possibility of losing its urban texture and identity. In order to preserve the authenticity of the city, urban equipment elements should be designed taking into account the city identity and aesthetic values (Bayazıt, 2018).

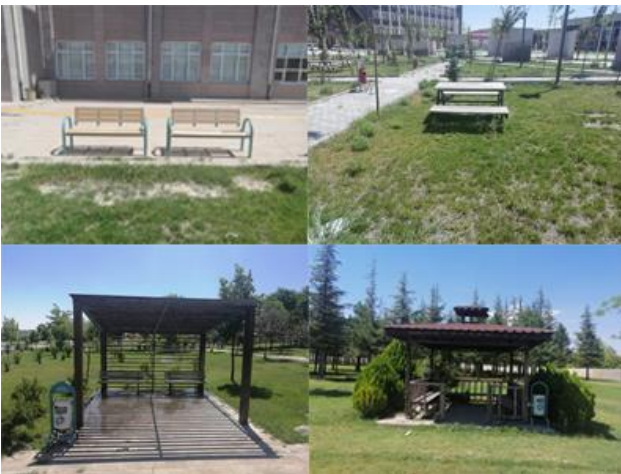
Figure 7. Seating elements in campus

The sitting elements in the campus were made by the Municipality of Niğde. It was observed that generally the same type of the seating unit was used in the campus. Seating elements are located in the campus in 3 different ways. One of them is the sitting elements under the bus stops. These seating elements are under the shading elements, and are made of wood. While the materials of the bus stops are concrete, the seating units are wooden, which does not provide an aesthetically beautiful appearance. Some seating elements have problems due to wear, breakage, etc. Seating elements in the bus stops were found to be sufficient in terms of functionality. While observing the aesthetic evaluation principles again, it was determined that there was no certain rhythm and balance.

Other sitting groups are located under the shading elements in certain areas in the campus. These seating elements are also made of wood. Since the shading elements which are surrounding them, are also wooden, an aesthetically beautiful view emerges.

In addition, flowers which located in the near these seating units, add visual richness to the areas. These seating elements, which were found suitable for functionality, were found insufficient numerically. Increasing the number of such seating elements in the campus will provide quality to campus. In the last group, there are only sitting elements used as benches. They are generally located in landscape areas or pedestrian roads. Wood was preferred as the material, but it is possible to see metal samples in the campus. We can say that these seating elements have an aesthetic appearance in themselves. However, they cannot show integrity in their areas. These seating elements are sufficient numerically and functionally suitable. Seating elements form integrity in the campus with repetitive and sequential rhythm.

The original seating elements reflect the urban texture and identity with wooden material and the use of wooden materials in the seating units is suitable for the weather conditions of the city. It is compatible with lighting, flower bed and trash cans around the equipment where wooden materials are used, and its compatibility with the environment is good. Seating elements in the campus are given in Figure 7.

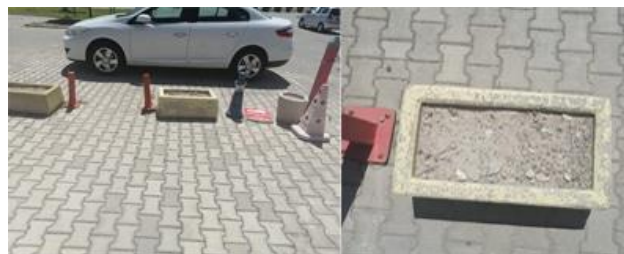
Figure 8. Plant crates in campus

Plant crates are used as a limiting element and aesthetic feature by creating a composition with the plant for most places (Sağlık et al., 2014). Plant crates in the campus are positioned so as not to interrupt pedestrian roads. Plant crates are mostly on green areas. They add aesthetic value to the campus with the colorful flowers. Although they have a harmony among themselves, they do not have a unique design.

They provide integrity in the campus in terms of color, material and environmental compatibility. In addition, functionality is provided to plant crates by using a limiting element in certain areas. In some areas, plant crates were supported with ground lighting, and a beautiful appearance was provided. Because they are at eye level in human scale, they provide detectability. Plant crates in the campus are given in Figure 8.

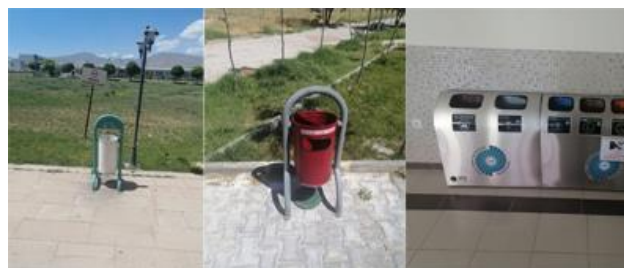
Figure 9. Trash cans in the campus

3 types of the trash cans were identified in the campus. The differences in form and design affect the visual aesthetics negatively and an integrity is not provided. All types have different properties in terms of color and shape. There are also different types of trash cans as material. The fact that some of them are on the pedestrian paths, and they are made of different materials affects the visual quality negatively.

Firstly, trash cans on the pedestrian roads were examined in the campus. Pedestrian roads are areas that are used extensively in the campus. Therefore, their positioning on the pedestrian roads was found suitable for functionality. However, it has been determined that some trash cans are located in the middle of the pedestrian roads, thus causing problems in terms of accessibility. In addition, in some areas, trash cans are insufficient numerically. This type of trash cans was generally made of metal, and there is a problem of compatibility with their environment. They are suitable for standards in terms of size. But most of them has a worn out appearance due to reasons such as neglected, vandalism, etc. This causes aesthetic problems in the campus. In the second group, there are trash cans with half-open mouth. These trash cans are usually at the entrance of the administrative and faculty buildings, and it is also possible to see the examples on the side of the pedestrian roads. These cans are made of wooden material and have an aesthetically beautiful appearance. These trash cans are generally neglected. The trash cans are positioned at the entrance of the building, which students spent a lot of time place, and these provided functionality to them. Finally, there are trash cans in the campus that can be located in the "semi-closed trash cans" group. These trash cans design is not unique. The maintenance criteria are not met and the worn appearance of the material spoils the aesthetic appearance. It does not provide reliability as hygiene. It is at a level that can create integrity with other accessories in harmony with color and environment. The measure-ratio balance is suitable for the environment and human ergonomics. Trash cans in the campus are given in Figure 9.

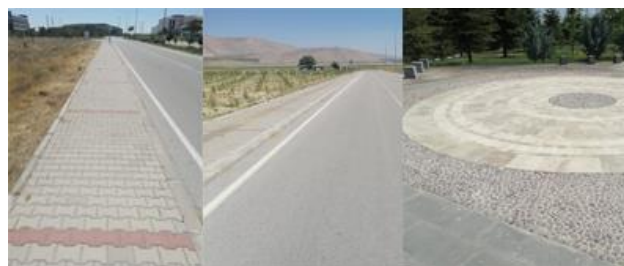
Figure 10. Flooring elements in the campus

They are used in planning considering the texture, color, line and form features of floor covering elements. The flooring elements that make up the floor, should complement the space in aesthetic terms, in addition to performing many functions.

The factors that are affecting the choice of flooring material, are the function of the area to be laid, traffic, cost,

climate, security, durability and local conditions. Floor coverings can offer aesthetically important visual alternatives besides pedestrian and disabled orientation, pedestrian bicycle and vehicle traffic separation, highlighting space, separating spaces (Başal et al., 1993). Different flooring elements are used for each land use in the campus. Interlocking paving stone was used on pedestrian roads. In some areas, it is possible to see concrete, andesite and natural stone flooring samples. Although it has an aesthetic appearance in visual, there are wear on the floors. This causes problems in terms of functionality. Asphalt flooring was used on the vehicle roads in the campus. As it is more durable than other flooring materials, it has been found suitable to use asphalt flooring in these areas. It is possible to see the areas where concrete materials are used in the vehicle roads. Asphalt flooring, which continues with a single color and material, does not provide highlighting and directing functional features to the campus, even though it provides color and material harmony among themselves. Basalt stone was preferred as paving material. In order to indicate the road level of the sidewalks and to emphasize the entrance of the buildings, it was tried to gain motion with a cream-colored cut stone. Grass was generally used in landscape areas. In some areas, there are soil cover and they are covered only with natural vegetation cover. The gaps which are found in some areas due to irrigation problems, cause a bad image. Yellow stripes of plastic material, which provide the guidance of the visually impaired, were used in the middle of the pedestrian roads. The width of these areas is 40 cm and they are less than the standard values. The disruptions in some areas of these bands cause problems in terms of transportation of disabled individuals. Its compatibility with pavement material and its integrated design, gives aesthetic values to the campus, while it is functional with its durable material. Although the flooring materials that are used in the campus, are not compatible with their environment in color and shape, they are suitable for functionality. Especially with the maintenance works to be carried out in these areas, the aesthetics and functionality of these areas can be increased. Flooring elements in the campus are given in Figure 10.

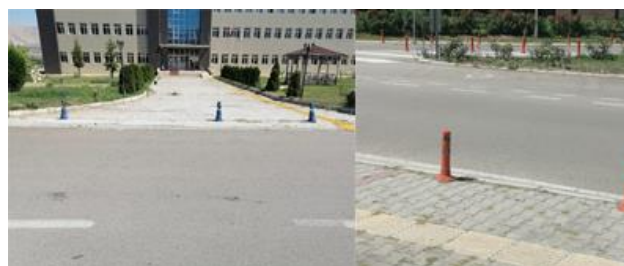
Figure 11. Restraint elements in the campus

Barriers are often used to create an obstacle for vehicles and to control the passage of vehicles (Sağlık et al., 2014; Bayazıt, 2018). There are two types of restriction elements in the campus. One of them is made of plastic material, the other is made of concrete. Since both of the limiting elements are not natural limiting, they are not aesthetics.

In particular, plastic limiting elements damage the aesthetic values of the campus. Functionally, both limiting elements are suitable. They provide a huge obstacle, especially in areas where entrance of the vehicles is not wanted. When we look at the campus scale, the limiting elements do not have a negative effect.

However, it does not reflect the identity of the city as an originality, but its similar or identical designs can be seen in other cities. Due to its limiting designs with plastic materials, the city harms its aesthetics and identity. Instead of these materials, the aesthetic value of the campus can be increased with natural limiting elements. Restraint elements in the campus are given in Figure 11.

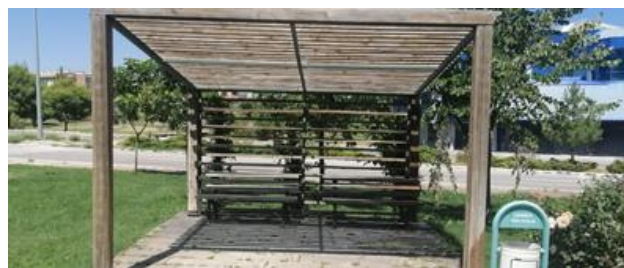
Figure 12. Shading elements in the campus

It was determined that there are 2 types of shading elements in the campus. One of them is the shadow areas that are created using only pergola. They do not have any sitting units under these areas, and they are used only for shadow purposes. They are made of wooden material and have an aesthetic appearance among themselves and environment. They were found suit in terms of functionality as they provide shade in hot climate. The other type of shading element is in the form of a gazebo and has seating units under. These seating elements are also made of wooden material and have an aesthetic appearance. In some of these occur wear due to vandalism and neglect. This damages the aesthetic appearance of the seating elements. These seating elements were found to be more functional since they contain both shade and seating units. Shading elements in the campus are given in Figure 12.

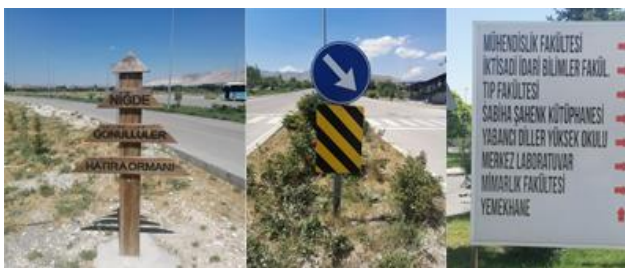
Figure 13. Signs and signboards in the campus

Signs and signboards; are informative and guiding elements in order to maintain and maintain order. The equipment that should be made in accordance with the aesthetic criteria, while functionally guiding the cities, gives the aesthetics visual and identity to the cities. The equipment elements in the campus were examined in two groups as signs and signboards. The signboards have been examined in two groups such for vehicles and users. The signboard on the vehicle roads are designed to determine the speed limit. They are made of metal and compatible with the environment. These signboards that was arranged in a row, are suitable for functionality. In terms of users, signboards are designed to locate faculty and administrative buildings. These are also made of metal sheet and have an aesthetic appearance. There are traffic signs on the campus as a signs.

These signs that were built on the edge of the pedestrian roads, are suitable for functionality and their designs are not unique. In addition to these uses, the side walls of the bus stop in the campus are also used as advertising or information area. These functionally useful areas are neglected. Signs and signboards in the campus are given in Figure 13.

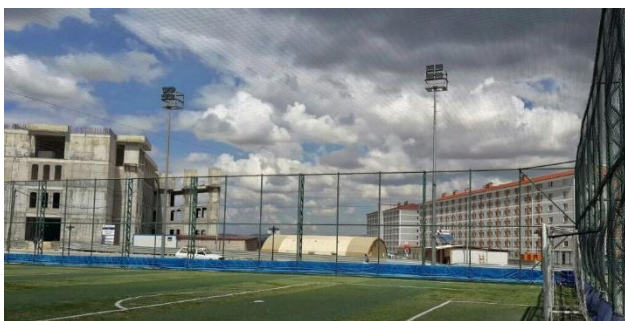
Figure 14. Playgrounds in the campus

There are two types of playgrounds in the campus, and they are open and closed form. One of them is in the form of an outdoor sports field, and is suitable for functionality. Especially in the evening, it has an aesthetic appearance with its lighting elements. The other playground is a closed area within the campus and various sports activities can be performed. It has been determined that most of the equipment elements in the campus are suitable in terms of functionality, but they are insufficient in terms of aesthetic values. Especially the maintenance and repair of the equipment elements are not done on time, causing visual pollution in the campus. In addition to negligence, there are aesthetic problems in equipment elements due to

vandalism, time-related wear and damage caused by climatic activities. Playgrounds in the campus are given in Figure 14. The study was compared with other studies. Kuşkun (2002) determined that the equipment elements were inadequate, their functions were lacking, they did not contribute to the urban aesthetics, but the people of the city were sensitive to the equipment elements in Erzurum. Şimşek and Yetim (2004) determined that there were problems in terms of aesthetics and functionality in urban equipment elements in their study in Tekirdağ. Alpagut (2005) concluded that there were many different types of equipment elements in the area, they are not designed according to the characteristics and needs of the area, and the equipment elements do not reflect the character of the city. Soydan and Benliay (2016) emphasized that color, shape and texture properties of the equipment elements were as important as the equipment elements functionality in their study.
