Park Equipment Information System the Case of Tayfun Gürsoy Park in Altınordu District, Ordu Province in Türkiye

Figure 1. Tayfun Gürsoy Park in Altınordu district of Ordu province

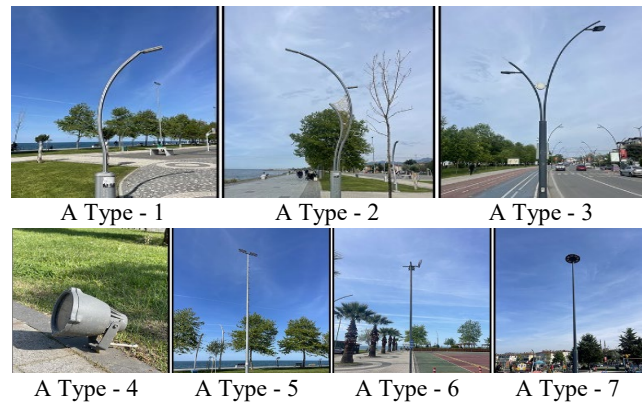
219 lighting elements were identified within the study area. These lighting elements are 36 vehicular roads, 43 coastal roads, 114 pedestrian paths, 16 grounds, 7 sports and children’s playgrounds, and 3 parking lots. There are 7 different types of lighting elements (Figure 6).

Figure 6. Types of lighting elements

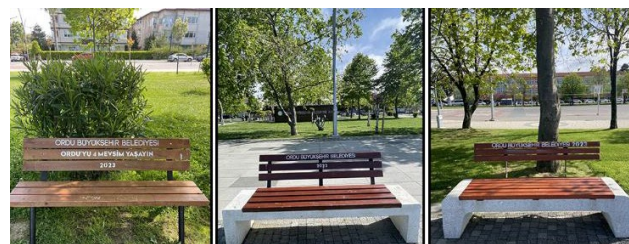
Within the study area, 63 seating units were identified. During the study, it was observed that there were 3 different types of seating units (Figure 8).

Figure 8. Types of seating units

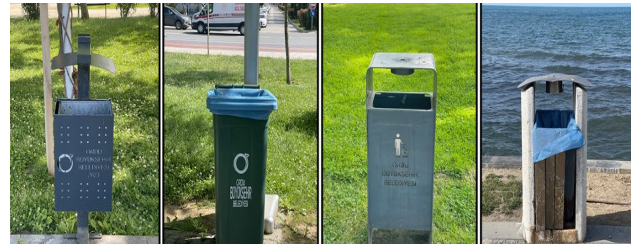
Within the study area, 74 dustbin and containers were identified. During the surveys, it was observed that there were 3 different types of dustbin and one type of container (Figure 10).

C Type - 1 C Type - 2 C Type - 3 C Type - 4
Figure 10. Types of dustbin and containers

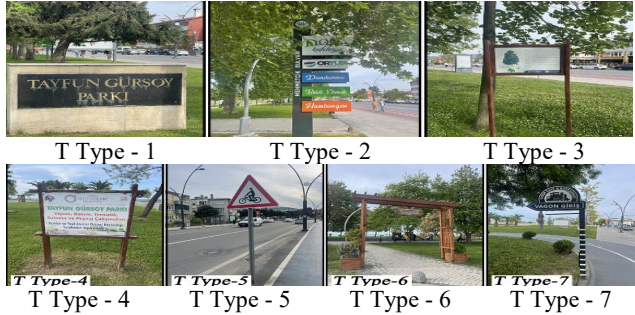
Within the study area, 36 signs and information boards of 7 different types were identified (Figure 12). Of these signs and information boards, 18 are information boards and 18 are sign boards.

T Type - 1 T Type - 2 T Type - 3
T Type - 4 T Type - 5 T Type - 6 T Type - 7
Figure 12. Types of signs and information boards

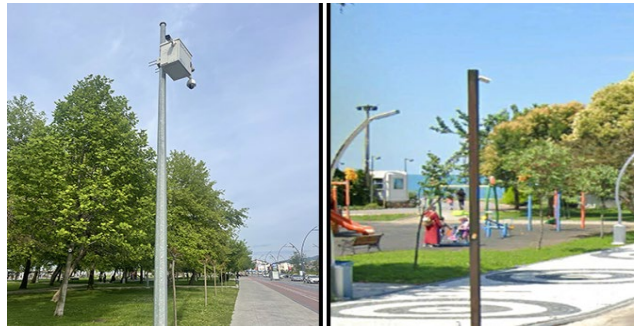
K Type - 1 K Type - 2
Figure 14. Types of cameras

A total of 10 cameras were identified within the study area. Of these, 4 cameras monitored the parking lot and 6 cameras monitored the interior of the area. During the surveys, 2 different types of cameras were identified (Figure 14).

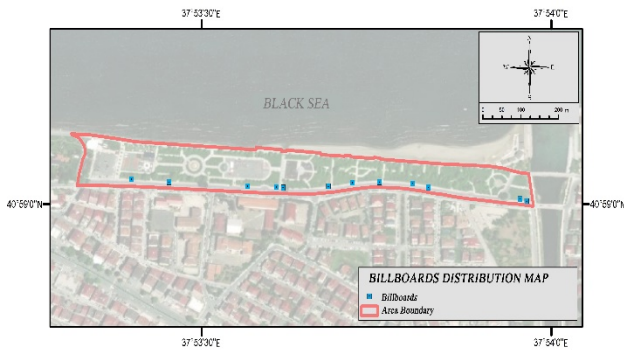
When analyzing the damage status of the billboards, it was found that 11 were not damaged and 1 was damaged. The distribution map of billboards within the study area is shown in Figure 17.

Figure 17. Distribution map of billboards in the study area

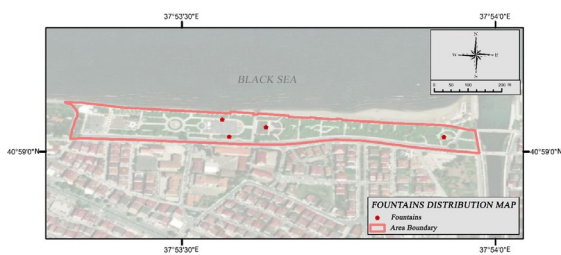
When the damage conditions of the fountains were analyzed, it was found that 3 of them were not damaged and 1 of them was severely damaged. The distribution map of the wells within the study area is shown in Figure 21.

Figure 21. Distribution map of fountains in the study area

- Floor coverings that do not pose a risk of tripping and slipping should be preferred for all persons in the park,
- Damaged equipments identified in the park should be repaired and their quality improved,

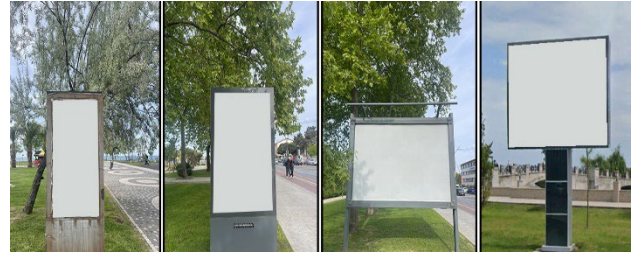
There were 12 billboards identified within the study area. During the surveys, 4 different types of billboards were identified (Figure 16).

R Type - 1 R Type - 2 R Type - 3 R Type - 4
Figure 16. Types of billboards

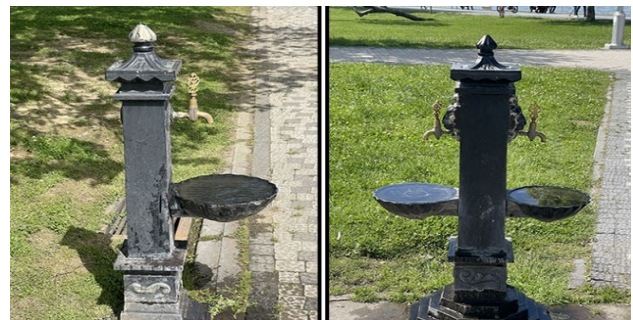
Within the study area, 4 fountains were identified. The investigations revealed 2 different types of fountains (Figure 20).

Figure 20. Types of fountains

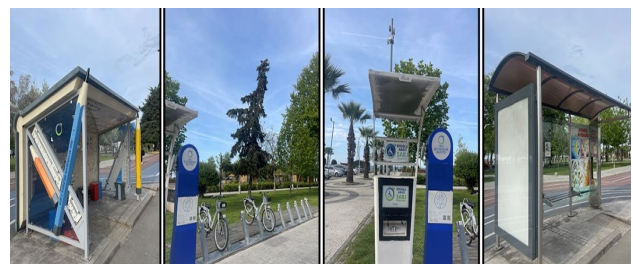
Within the study area, 4 stops were identified. All 4 stops are of different types (Figure 22).

Figure 22. Types of stops
